NASA CR-425

INVESTIGATION OF THE SONIC FATIGUE CHARACTERISTICS OF RANDOMLY EXCITED ALUMINUM VISCOELASTIC PANELS AT AMBIENT TEMPERATURES

Prepared under Contract No. NAS 1-4728 by
NORTH AMERICAN AVIATION, INC.
Columbus, Ohio
for Langley Research Center

NATIONAL AERONAUTICS AND SPACE ADMINISTRATION • WASHINGTON, D. C. • APRIL 1966

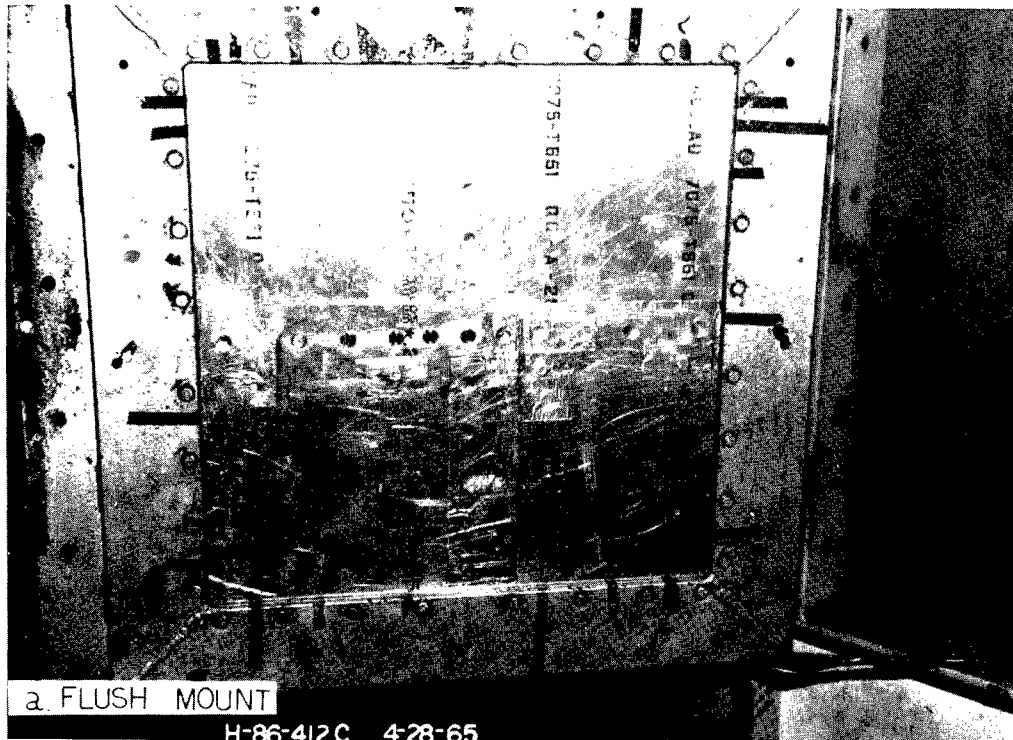
FIG. 21 ARRANGEMENT OF MICROPHONES FOR CORRELATION STUDY
